Subject: Department of Natural Resources Washington Geological Survey,
School Seismic Safety Assessment Project, Contract No. AE 410 -
Seismic Evaluation for **Burlington-Edison School District**

School Buildings Evaluated in the Burlington-Edison School District

1. Edison Elementary School, Original Building

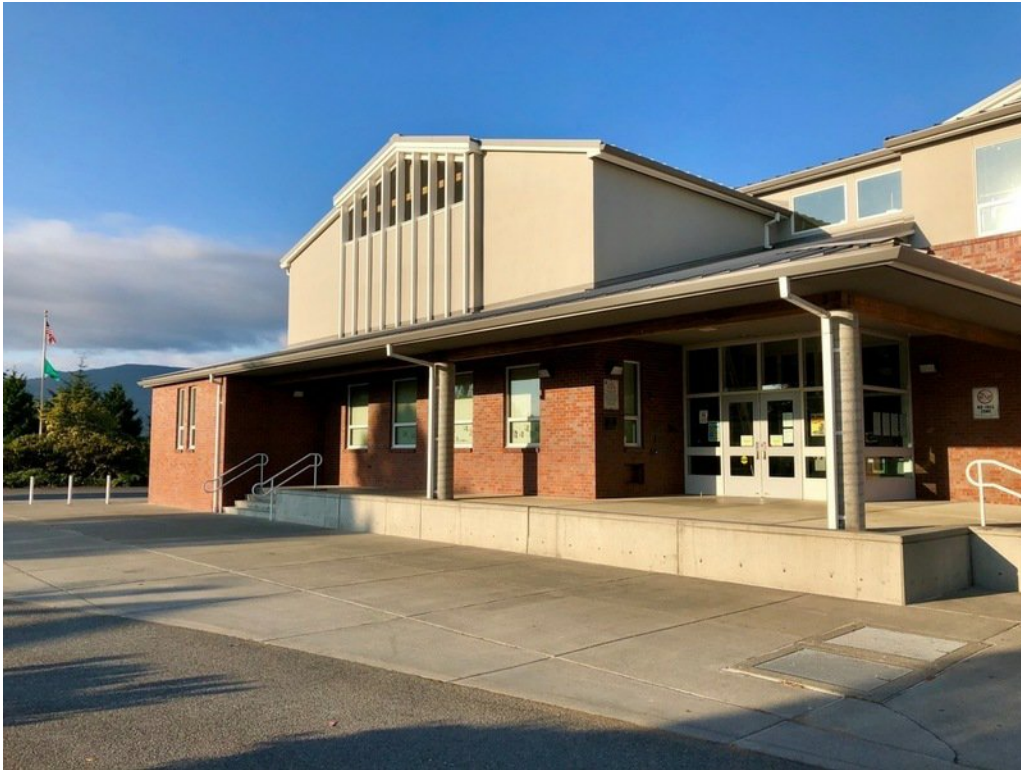
Figure 1-1. Exterior west side of building at the main entrance.

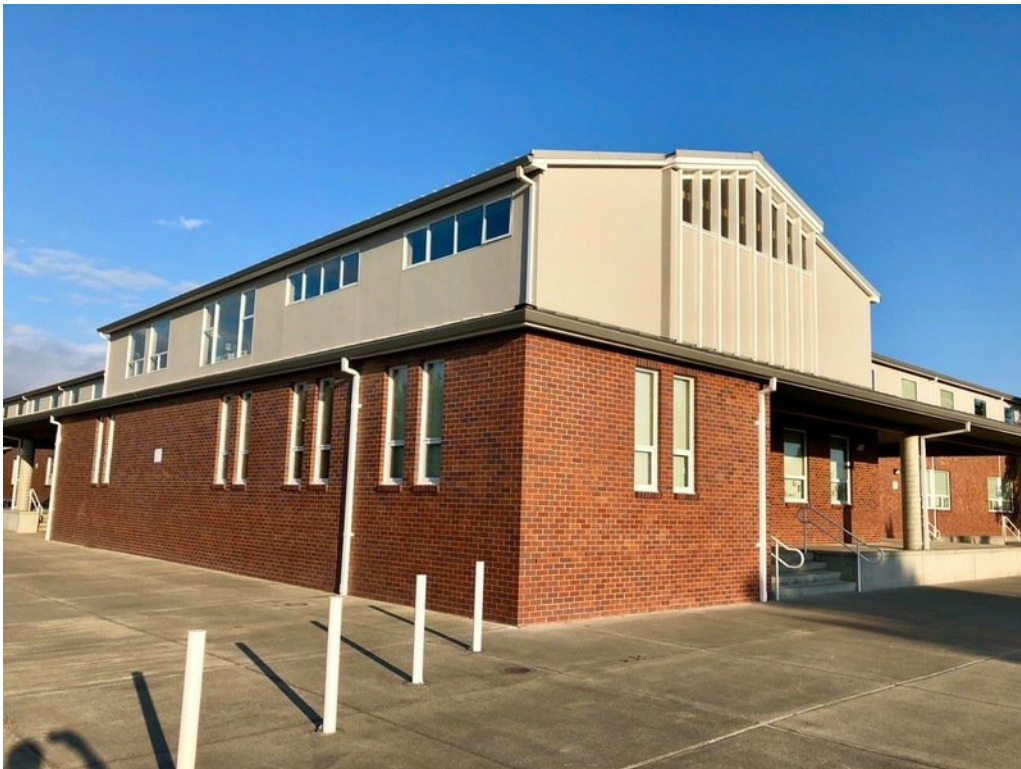
Figure 1-2. Exterior northwest corner near entrance.

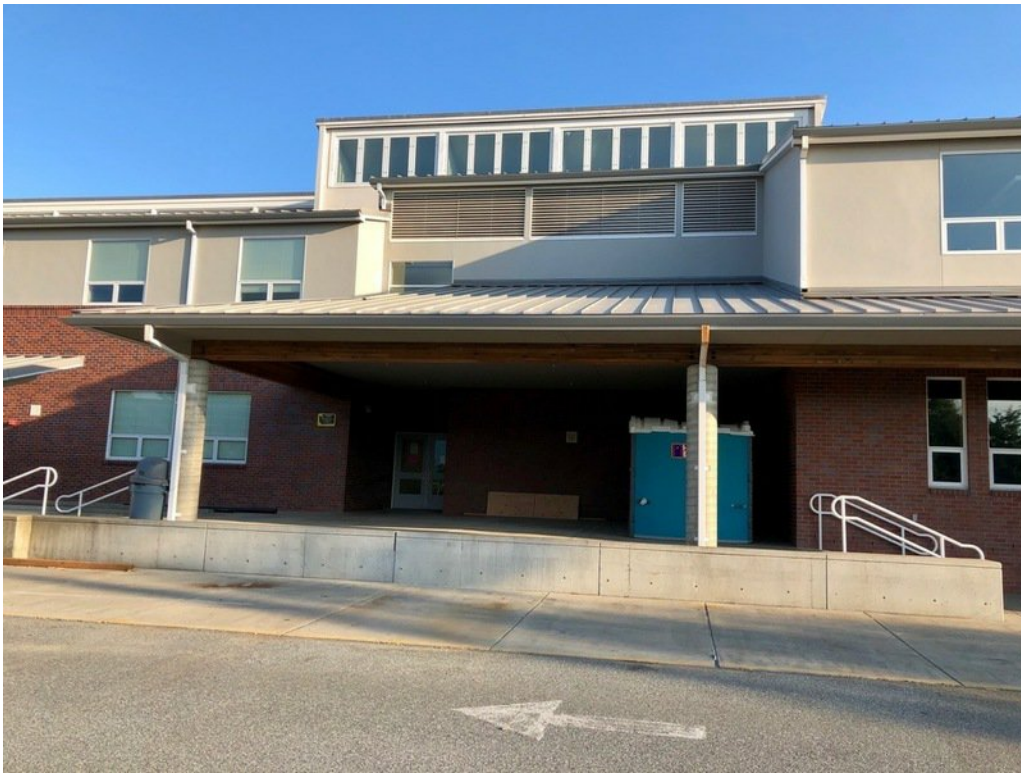
Figure 1-3. Exterior north side of building at the loading dock area.

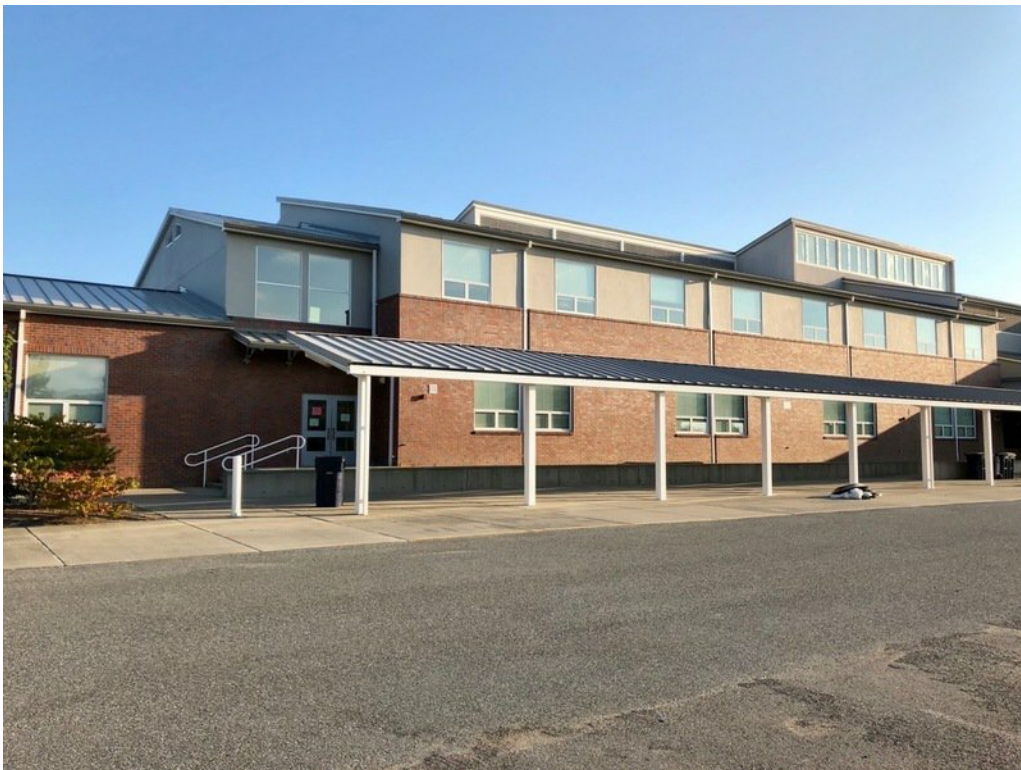
Figure 1-4. Exterior north side of building.

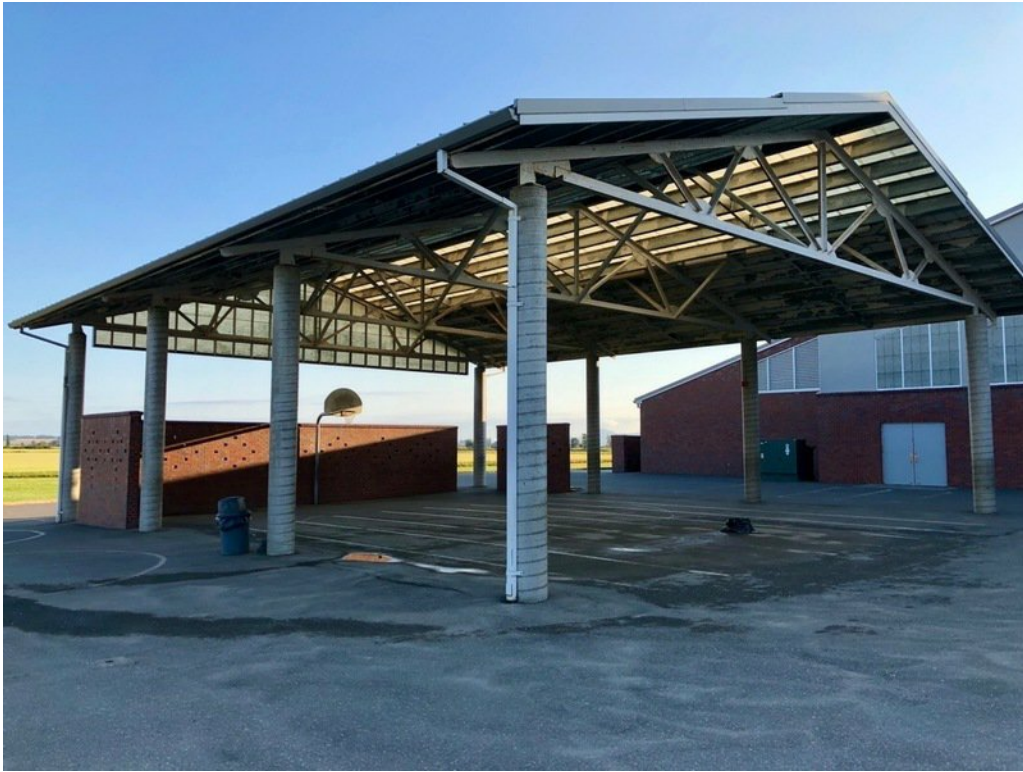
Figure 1-5. Covered play area structure at the exterior southeast side of the Original Building.

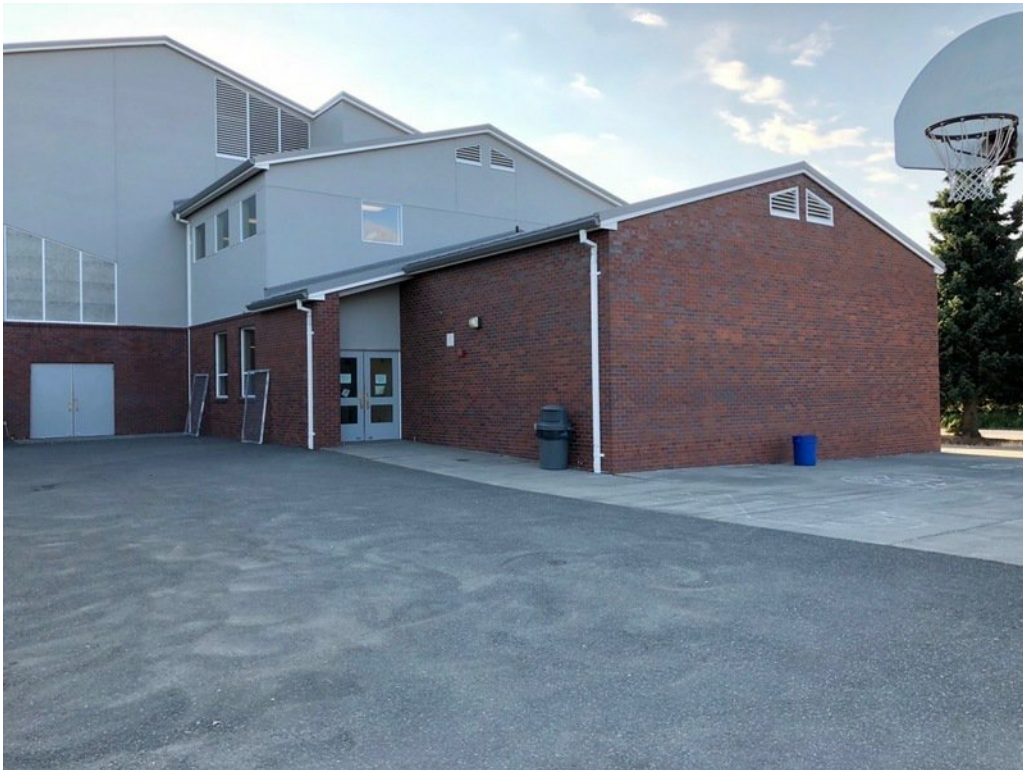
Figure 1-6. Exterior east side of building.

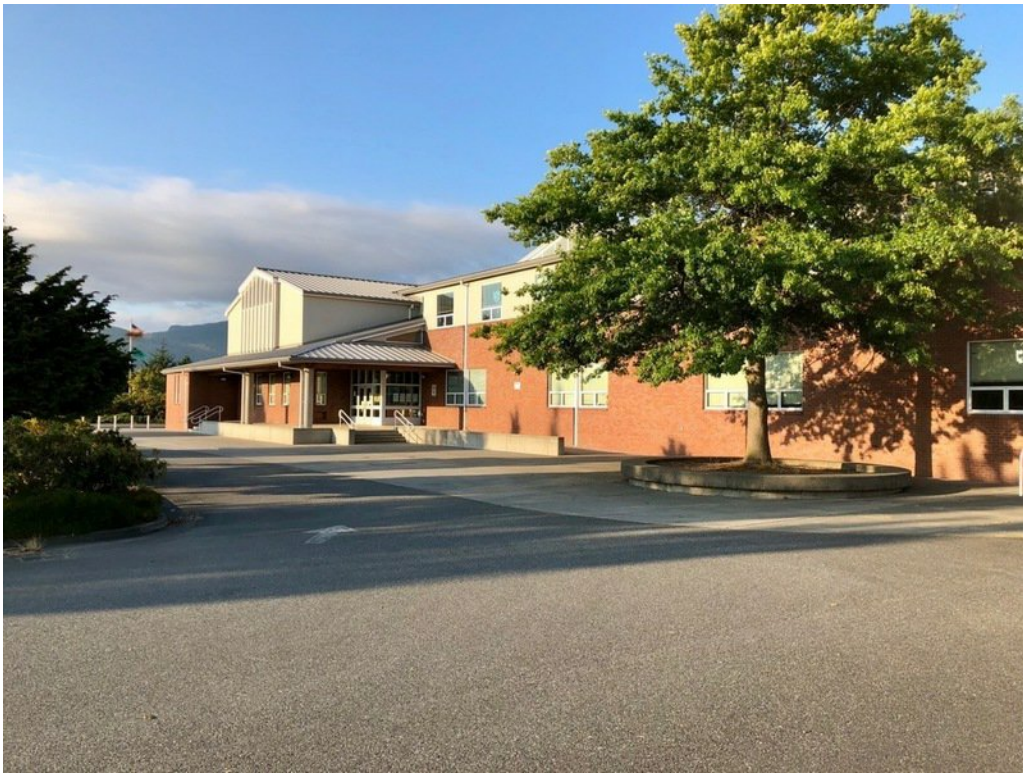
Figure 1-7. Exterior west side of building.

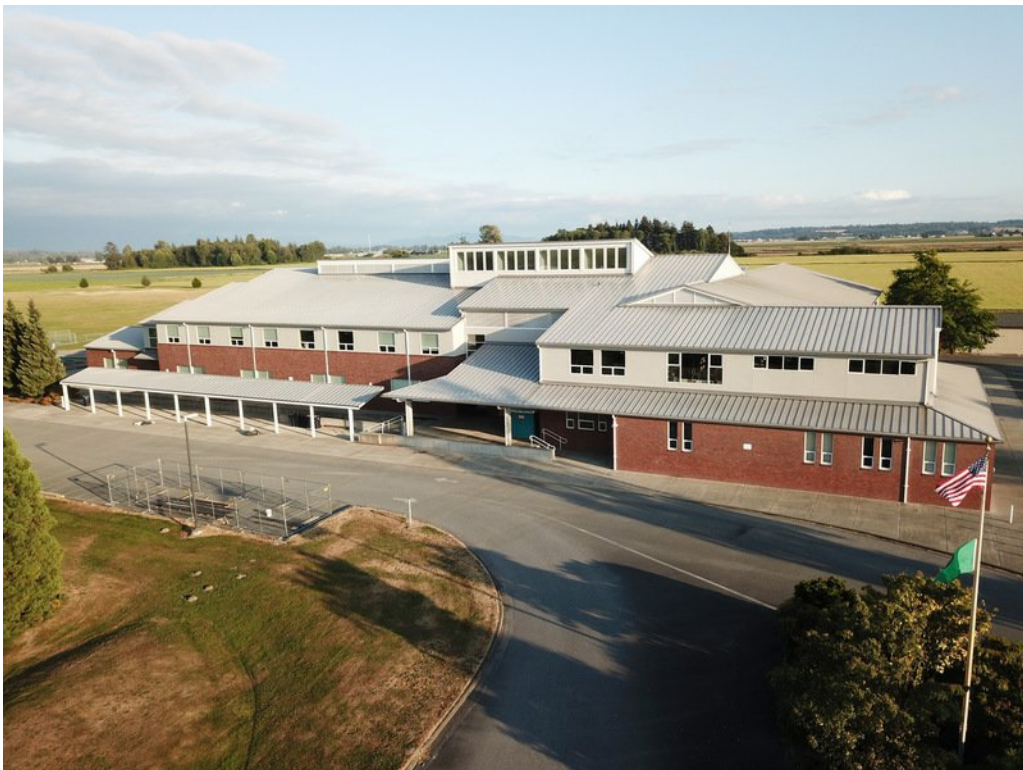
Figure 1-8. Exterior north side of building.

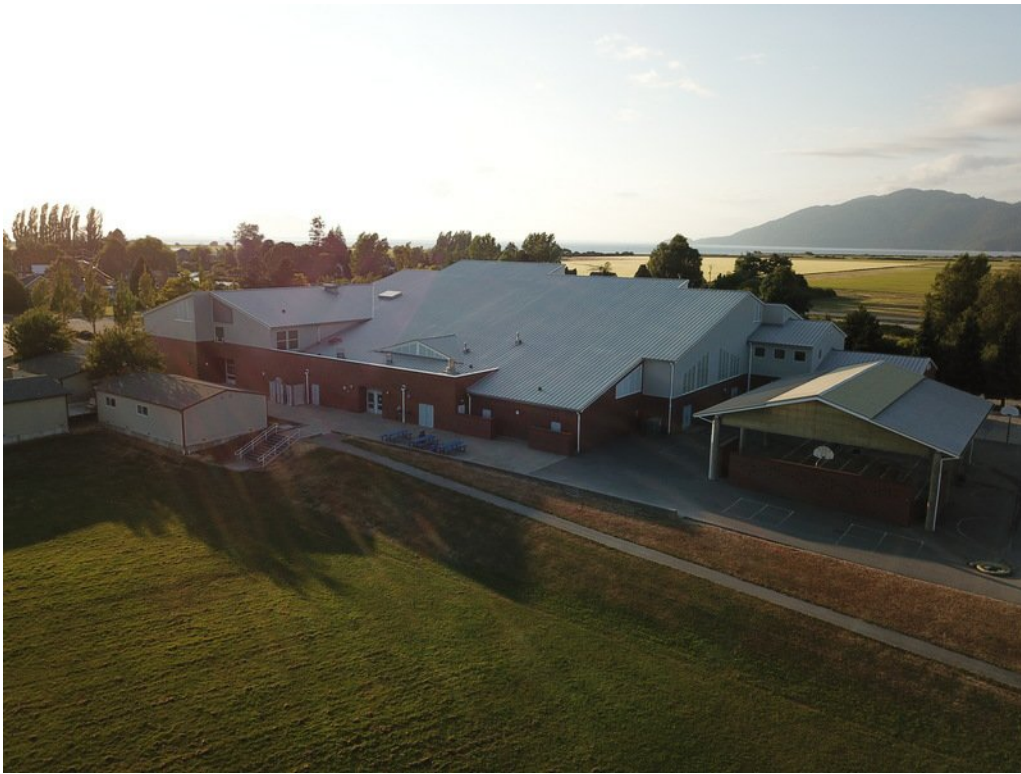
Figure 1-9. Exterior south side of building.

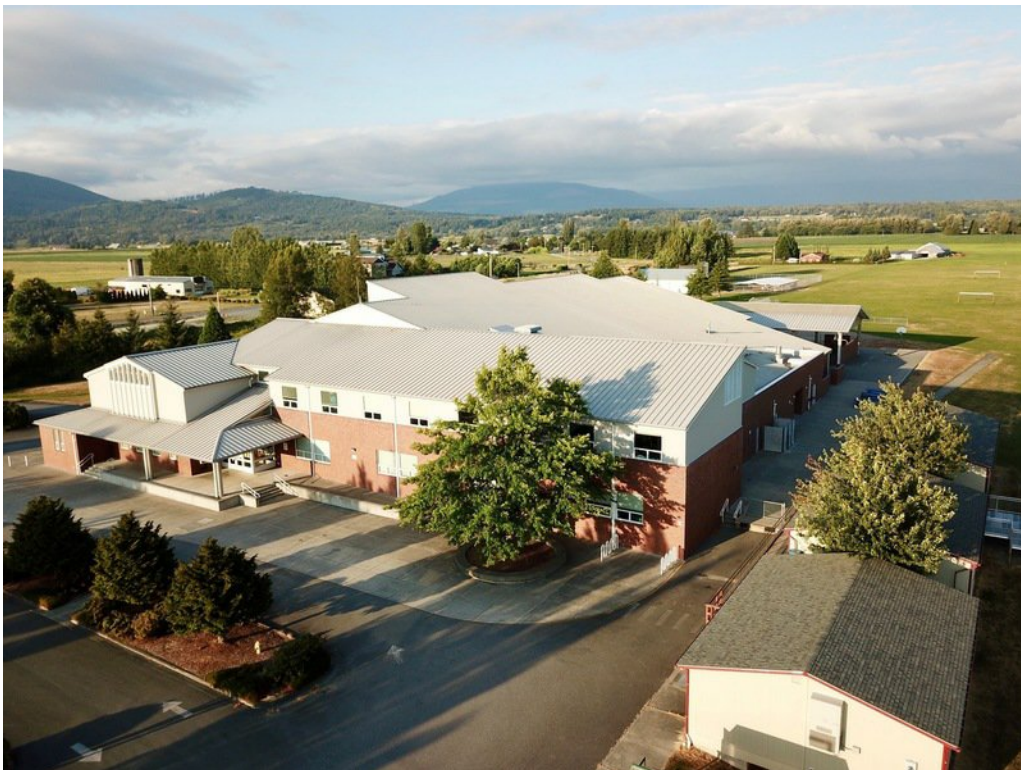
Figure 1-10. Exterior west side of building.
